NATIONAL TRANSPORTATION SAFETY BOARD

HAZARDOUS MATERIALS SPECIAL INVESTIGATION REPORT

COLLISION BETWEEN
A TRACTOR-SEMITRAILER
TRANSPORTING BOMBS AND
AN AUTOMOBILE,
RESULTING IN FIRE AND EXPLOSIONS
CHECOTAH, OKLAHOMA
AUGUST 4, 1985

NTSB/SIR-87/01

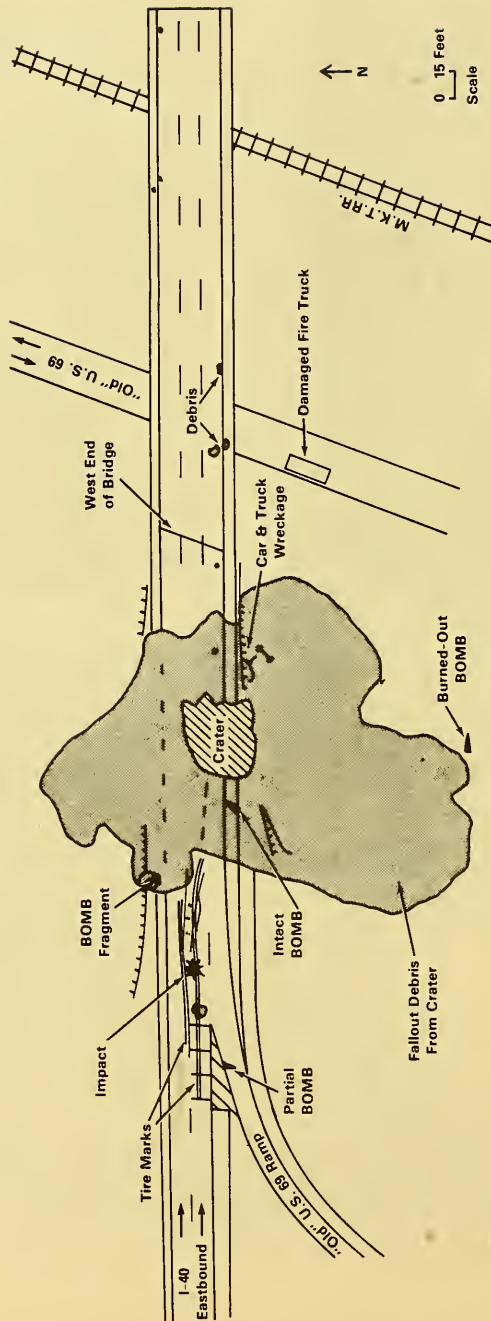
Figure 4.—Diagram of accident site.

The 61st team arrived at the accident site at 8:32 a.m. The 61st commander said that, based on his observation of thin, gray smoke and relatively small fires, he decided little danger of further detonation existed. He requested local emergency response personnel to extinguish grass and brush fires, and he advised local response personnel that evacuation distances could be reduced to a perimeter surrounding the accident site. Personnel from the 61st inspected the area and found one intact, 100 percent filled bomb adjacent to the accident site, one intact 80 to 90 percent burned out bomb about 150 to 175 feet south of the accident site, and one 3 1/2-foot-long rear section of a bomb (filled with explosive filler) approximately 150 to 175 feet southwest of the crater. (See figure 4.)
